Comments on repairing Qualcomm 10 volt power supplies  
(Text and Diagram updated 3/8/2004)

(Excerpts from an email from WA3PTV to WB6IGP, of Feb 04,2003)

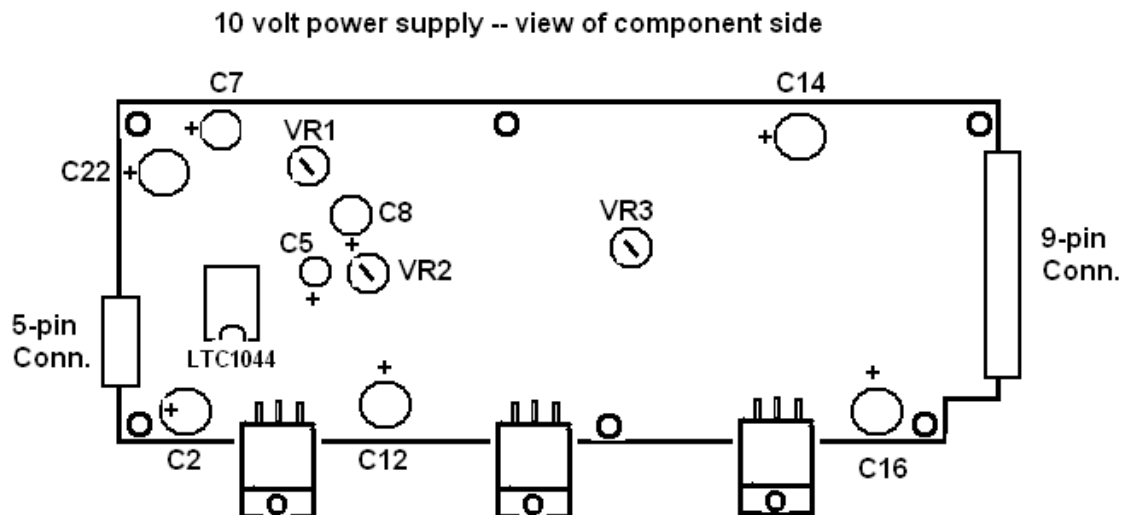
With +12.5 volts input, If the minus 5 volt no-load output is between negative 0.2v and negative 4.5v then the failure is most likely to be the two electrolytics, C2 and C22 mentioned in the letter above.

If the minus 5 volt output is a positive value of about +0.8 volts, then the LT1044 is most likely defective. A 7660 negative generator is a good replacement. ((The 7661 (which we have stock of) is another pin compatible replacement but is limited in output current (2 Ma.) and under test to see if it will support the power amp current requirements. ))

Hello Chuck. I was able to repair 11 out of 12 Power supply boards that I now have. 99% of the problems with these boards centers around the 2 electrolytic filter caps, C22 and C2 in the -5 volt dc/dc converter section. The 2 caps, 120uf/16volt, cost less than 2 dollars.
